Living Shoreline at Cannon's Point Preserve

Cannon's Point Preserve Living Shoreline

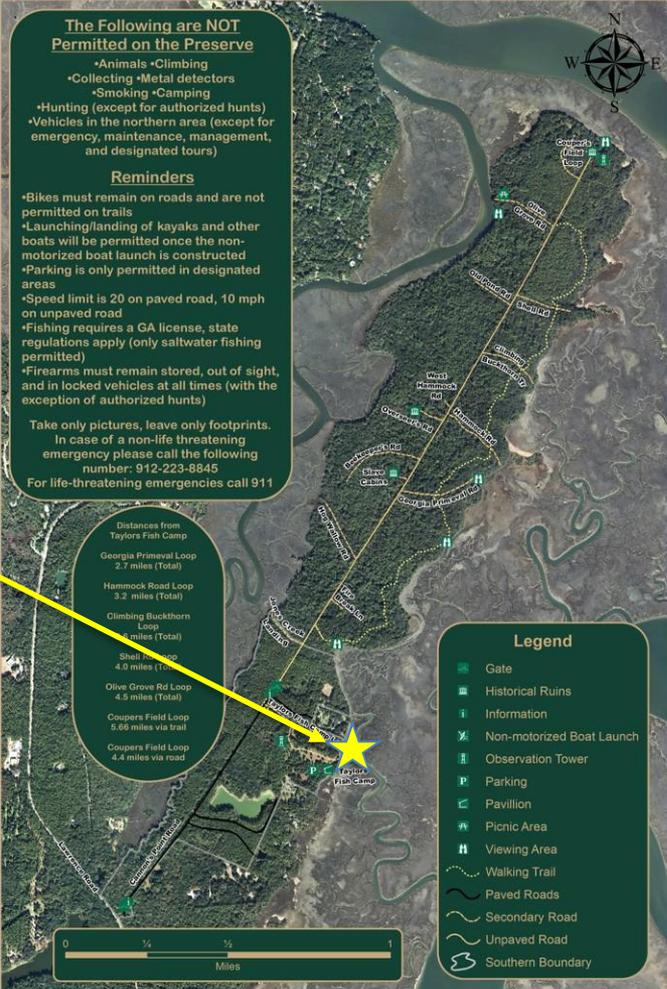
Location of the living shoreline at Cannon's Point Preserve

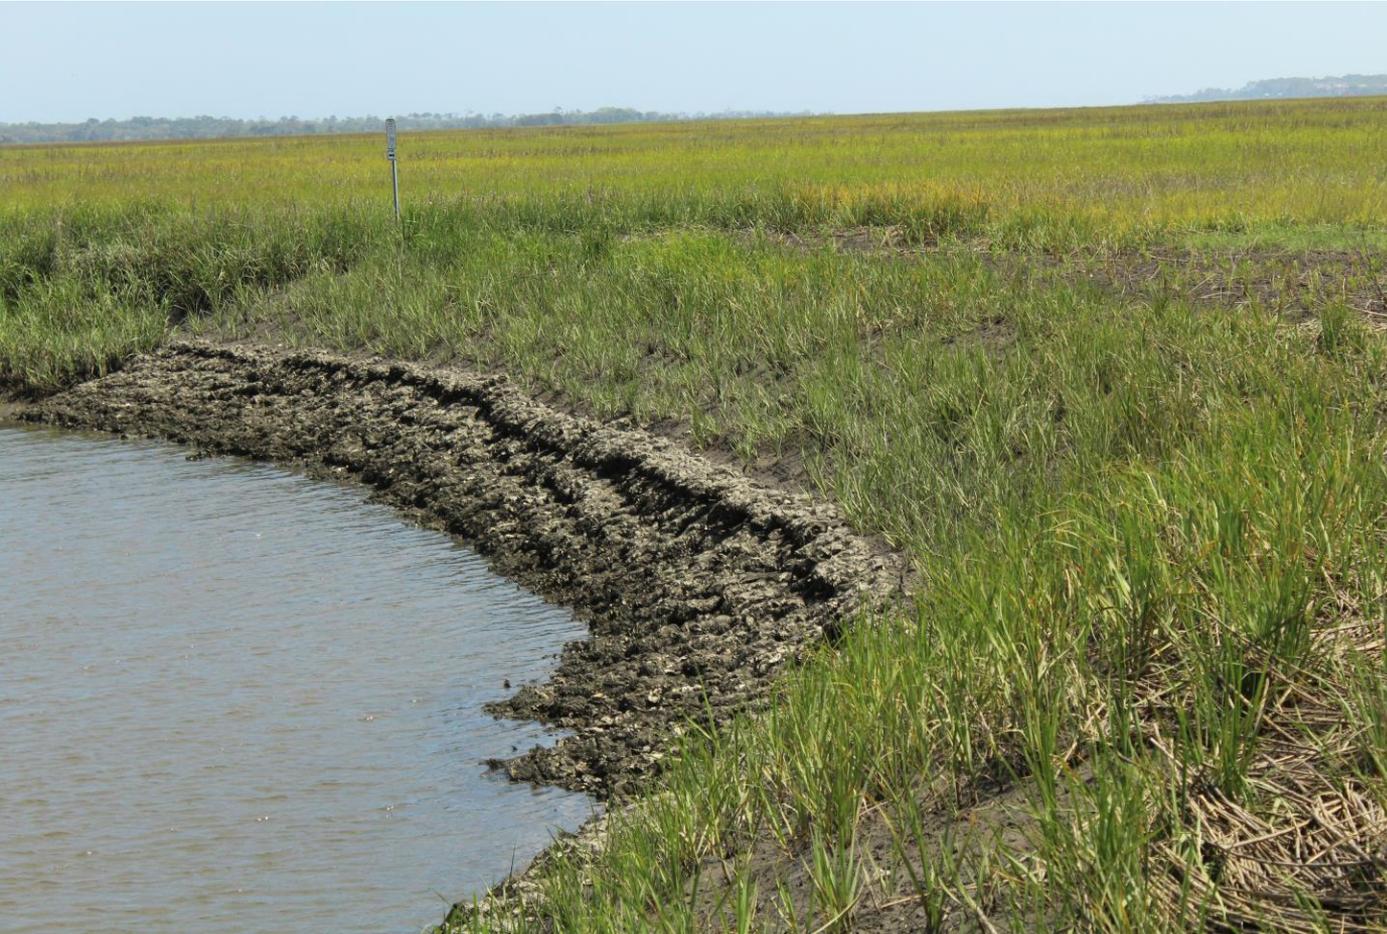
Living Shorelines use **bioengineering** in combination with native vegetation plantings to **stabilize** or **enhance** wetland habitats.

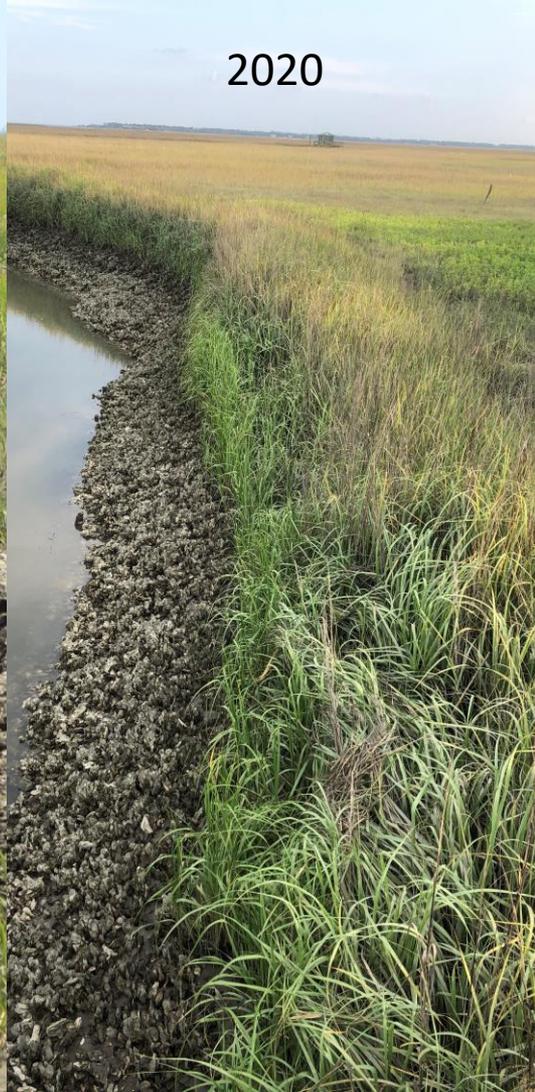
Engineering plans for Cannon's Point Preserve living shoreline

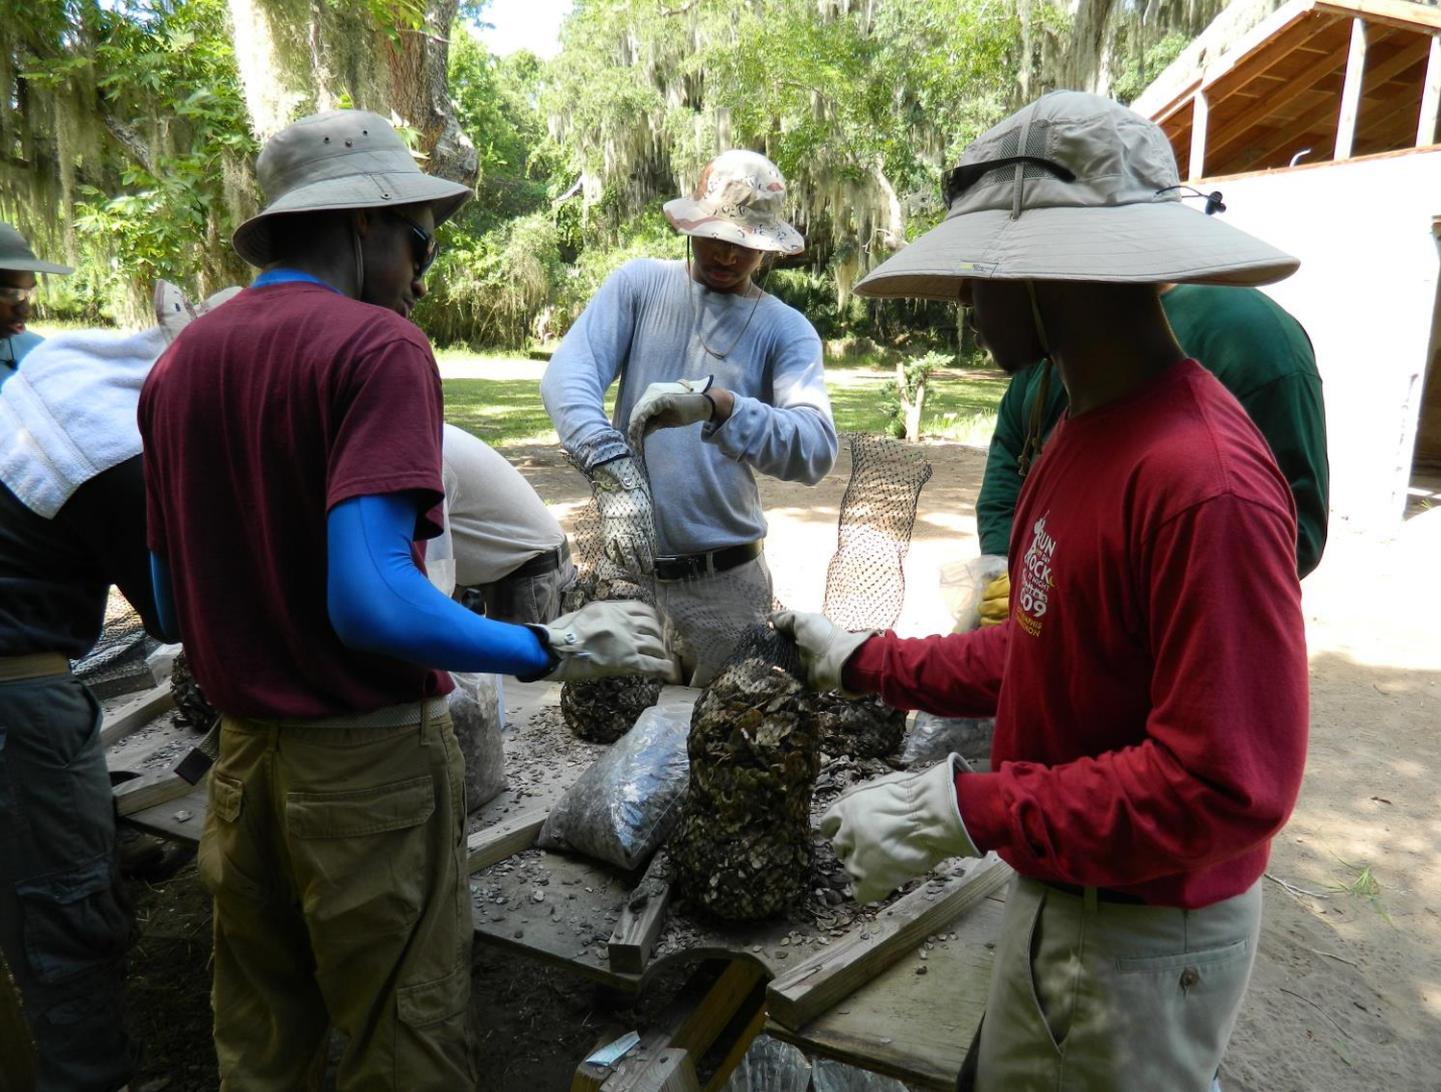
The Nature Conservancy's interns bagging the shells of **oysters**, a keystone species

- **8,000** bags of oyster shells used to start an oyster reef
- **637** volunteer hours
- *Spartina alterniflora* plugs and other native vegetation were planted
- The fourth demonstration living shoreline project in Georgia and the **first** to be accessible by vehicles, allowing it to be widely used for educational and training purposes
- Completed in **October 2015**

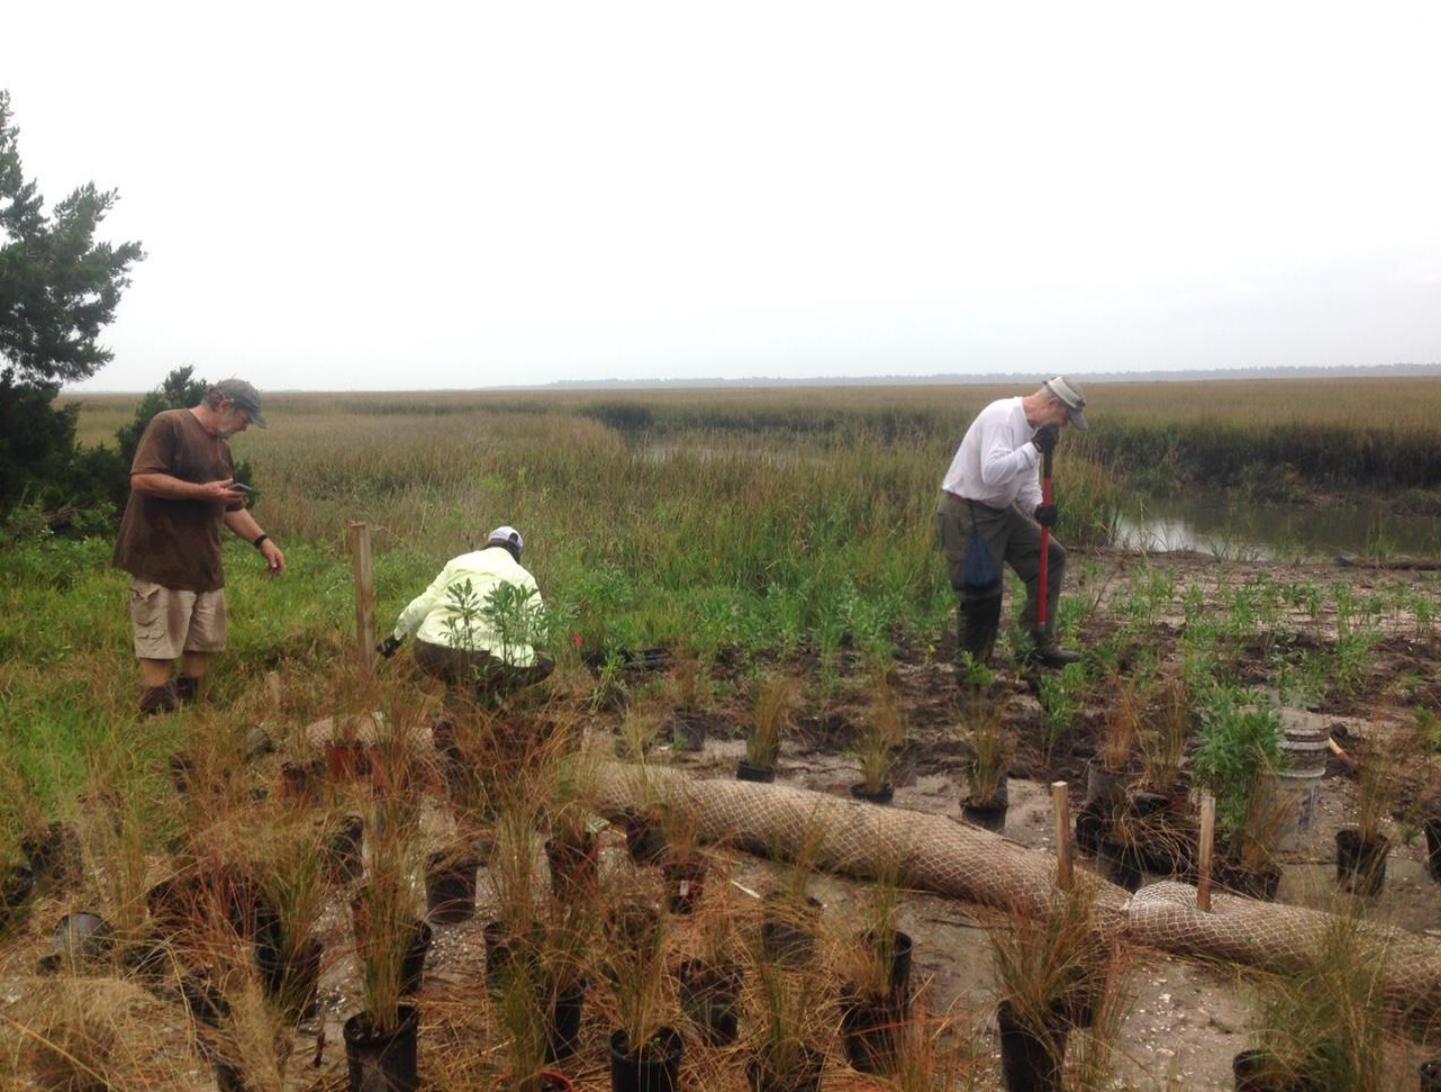
Plugs of another perennial deciduous native coastal plant, *Spartina alterniflora* (cordgrass), after being newly planted in 2015

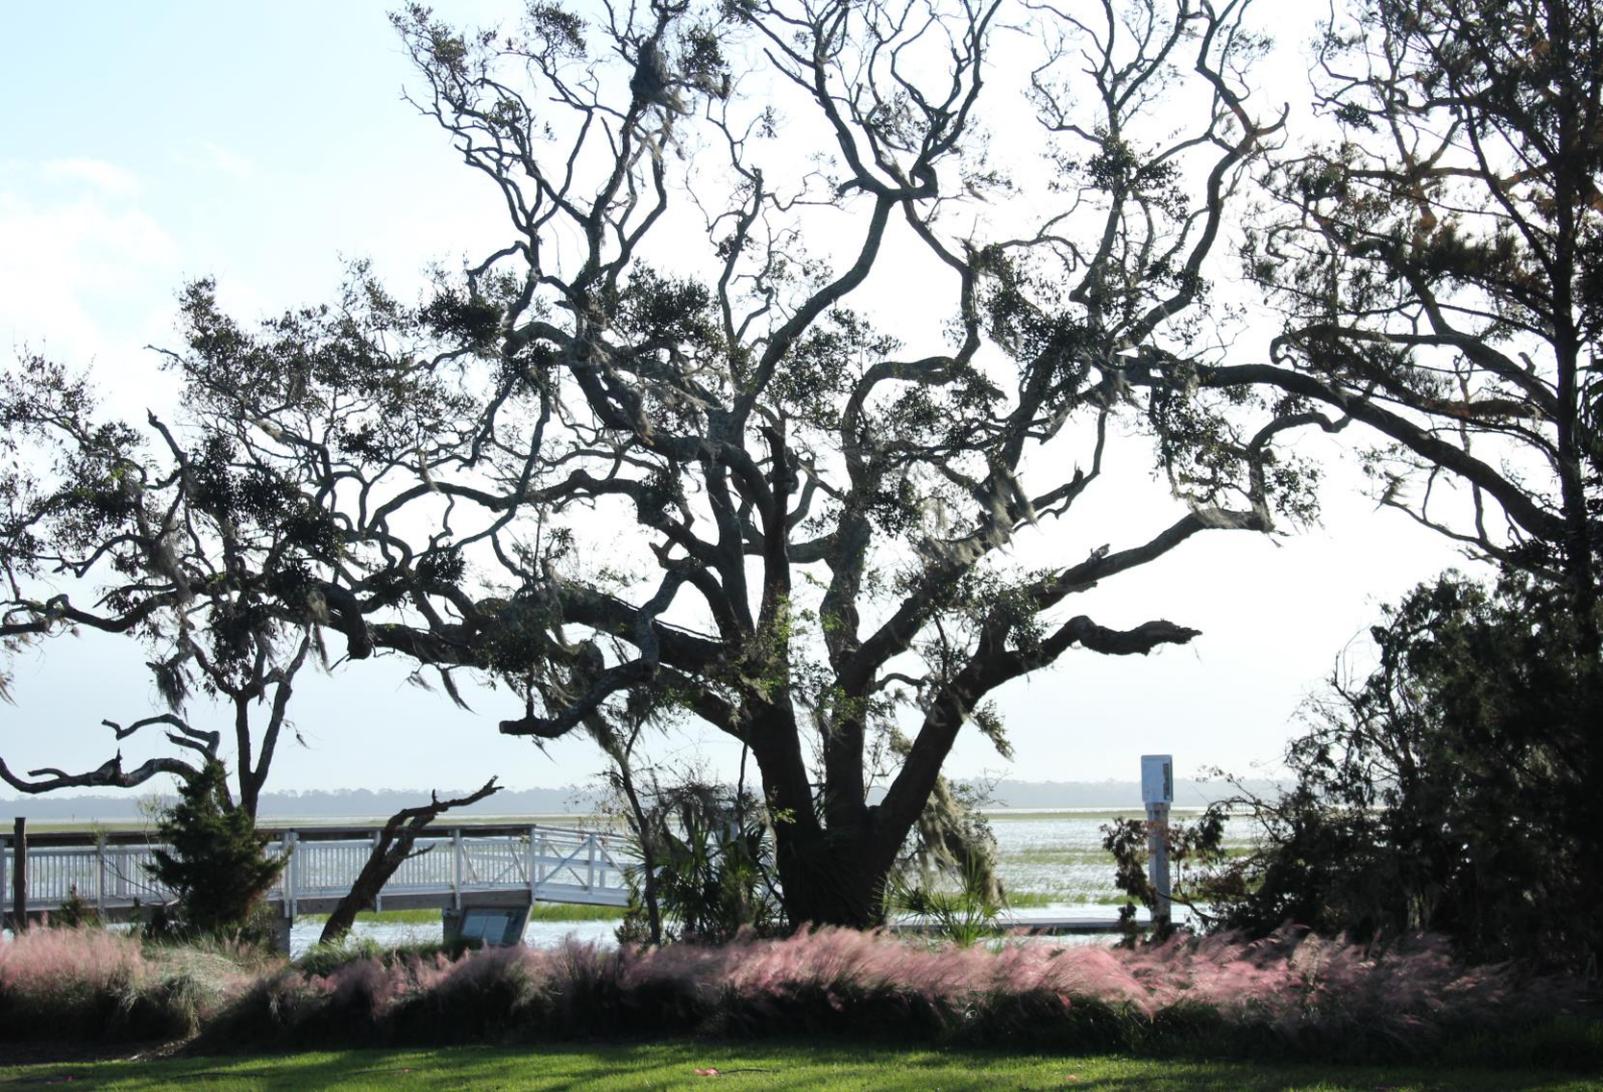
View of the CPP living shoreline site – with blooming *Muhlenbergia capillaris* (aka Muhly grass) -- during a king tide

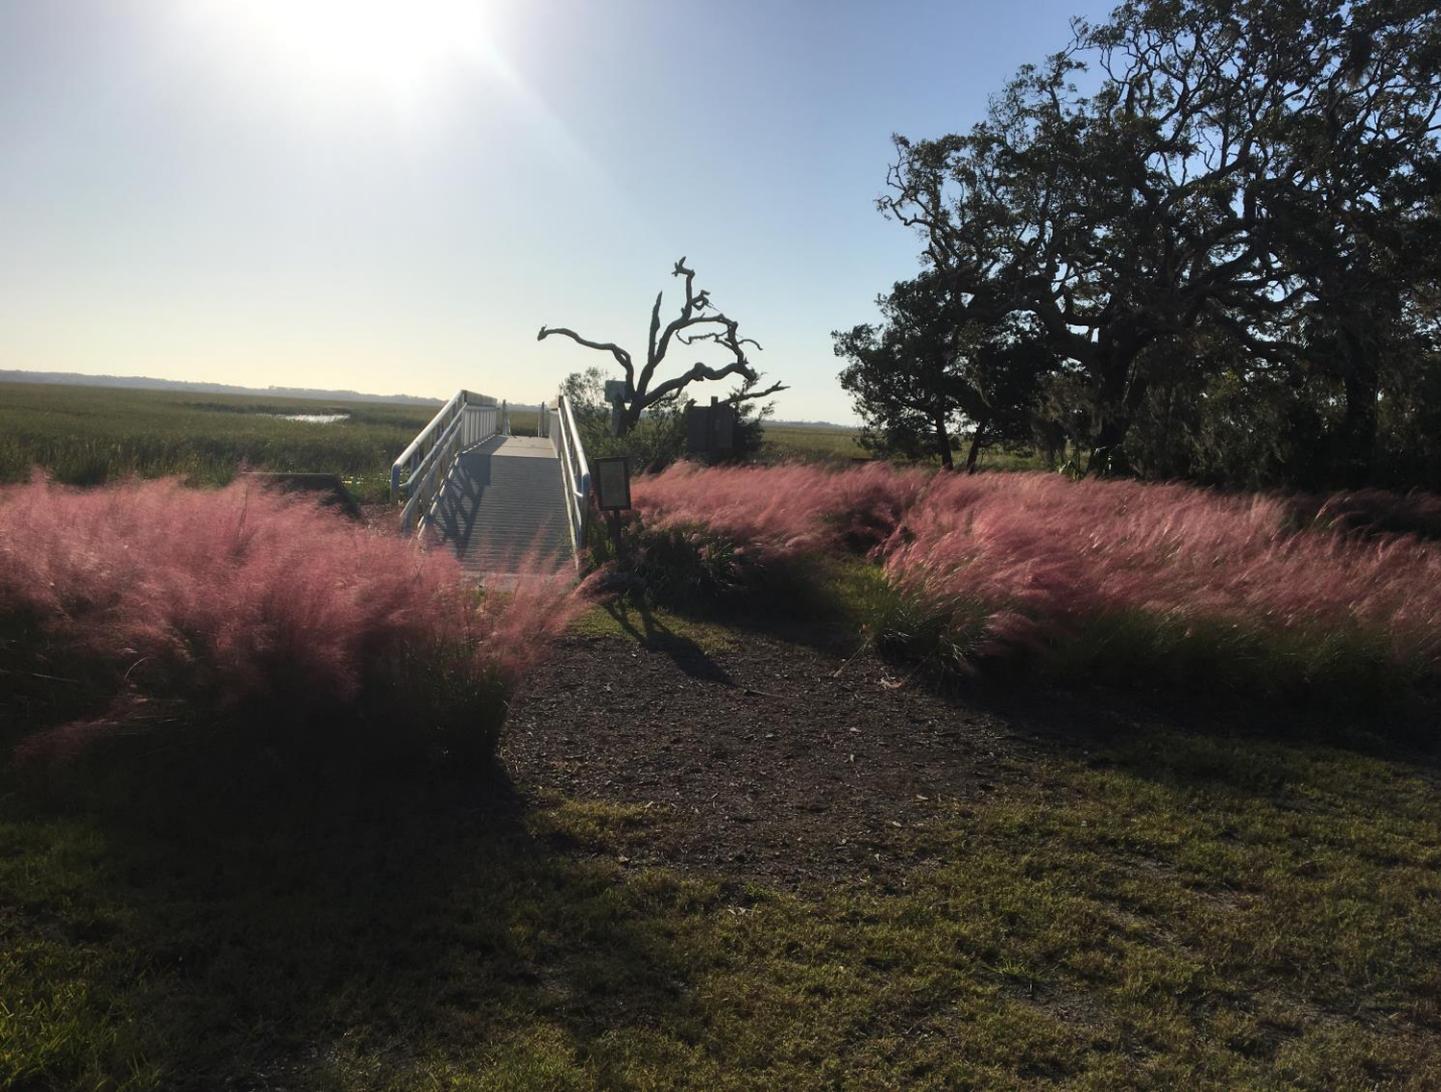
Upland
Component of
the living
shoreline with
native
vegetation
including
***Muhlenbergia
capillaris***

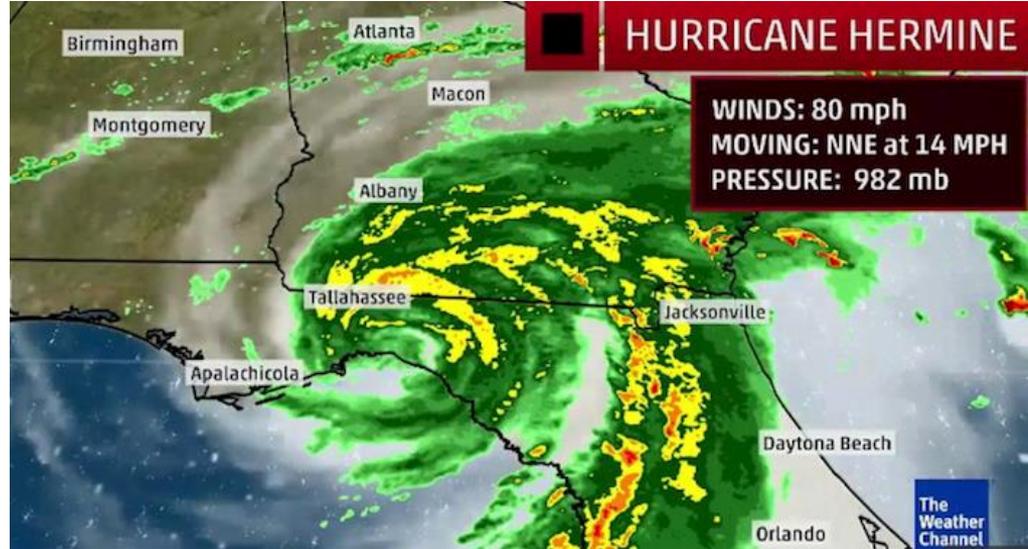
- Friday, September 2, 2016
- Tropical Storm for the Georgia Coast
- Wind gusts of 56mph SSW
- 0.77 inches of rain
- Tides of 7.21 feet
- The storm tracked NNE with only tropical storm force winds reaching St. Simons Island as the storm decreased in strength after making landfall
- Inspection of the living shoreline after the storm verified that the project remained **intact and stable** and served to protect the adjacent upland

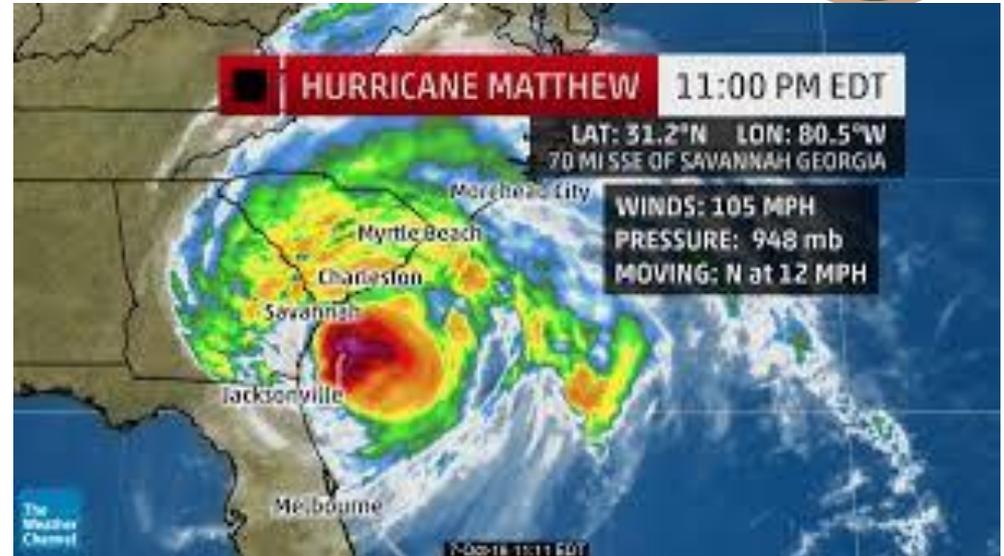
- Saturday, October 8, 2016
- Category 2 hurricane
- Recorded wind gusts on St. Simons Island were 62 miles per hour NNE
- 7.8 inches of rain
- Mandatory evacuations were issued for coastal Georgia
- The eye of the hurricane was approximately 50 miles off Georgia's coast with the bands reaching over the entire island
- Inspection of the living shoreline after the storm verified that the project remained **intact and stable** and served to protect the adjacent upland

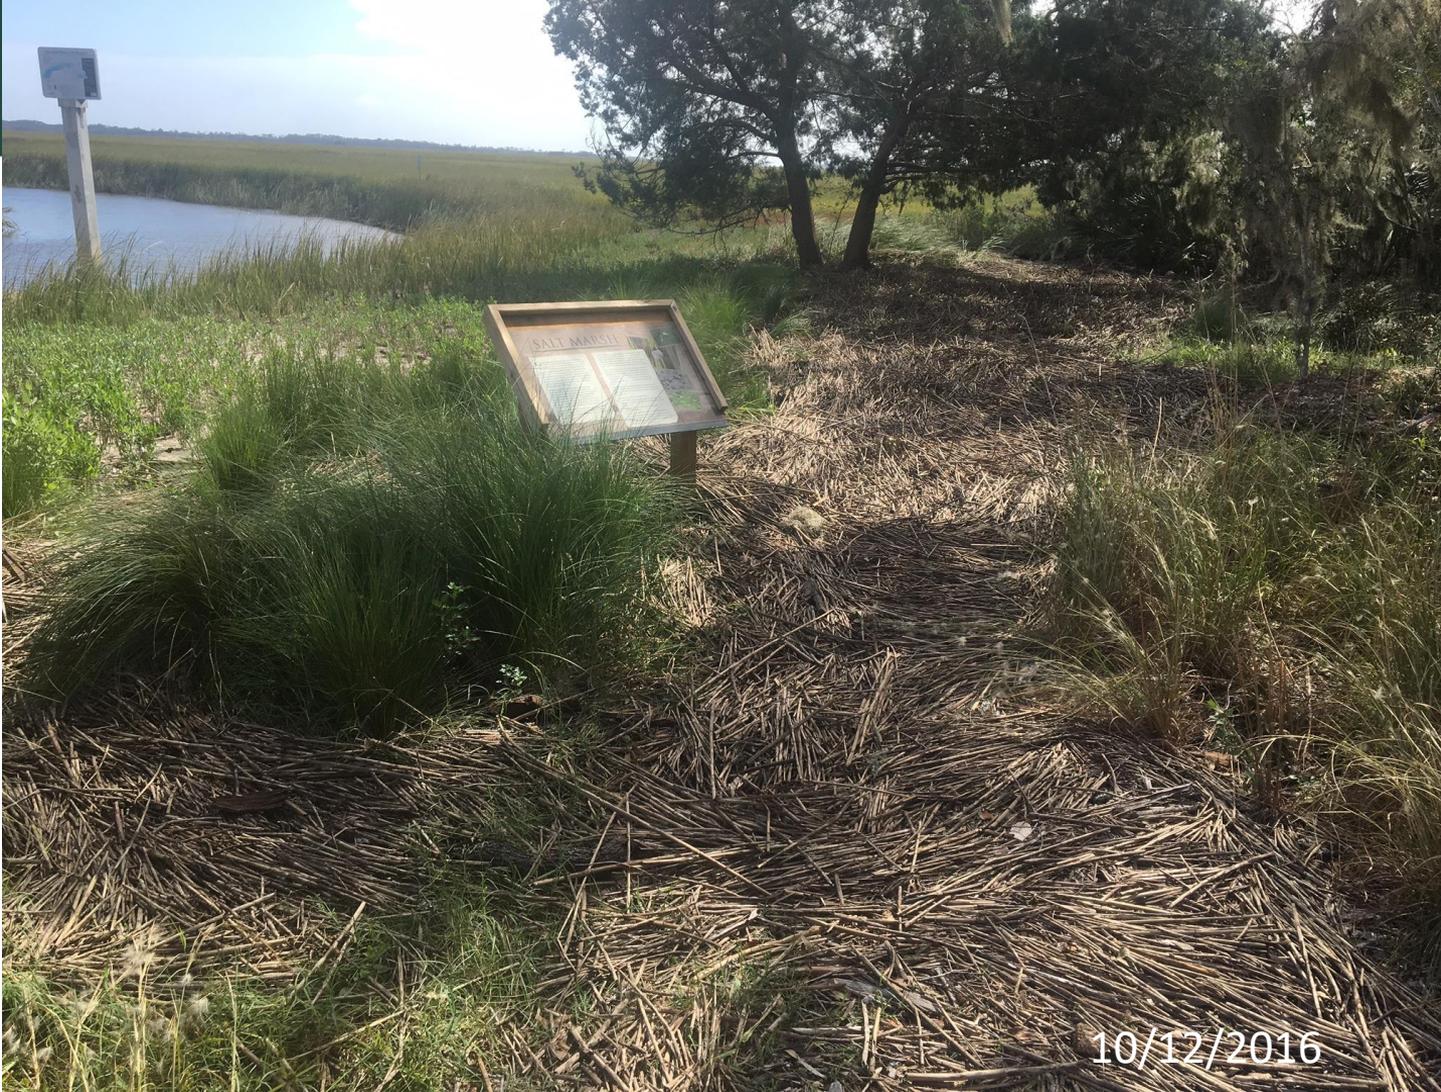
10/12/2016

Site inspection on October 12, 2016 verified that the storm surge came up along the project, depositing wrack between the *Borrichia frutescens*/*Muhlenbergia capillaris* transition zone

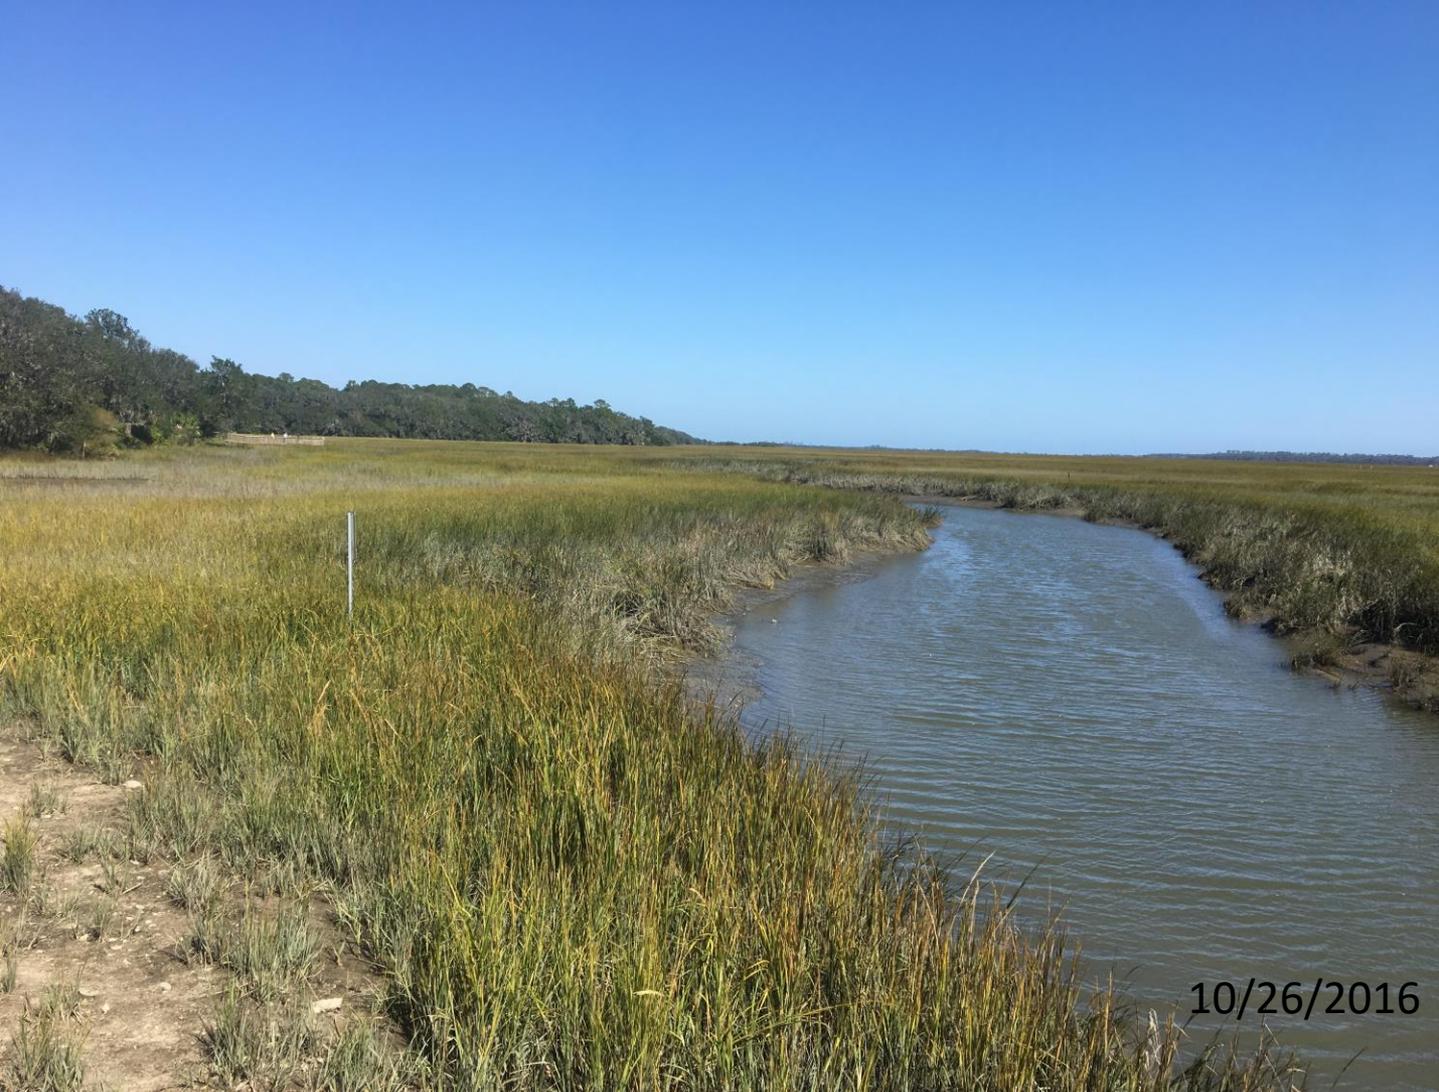
10/26/2016

Looking west along Lawrence Creek, notice that the natural *Spartina alterniflora* appears to be heavily impacted as opposed to planted *Spartina alterniflora* along the living shoreline. This is likely due to the storm surge and helps to verify the **stability of the living shoreline project.**

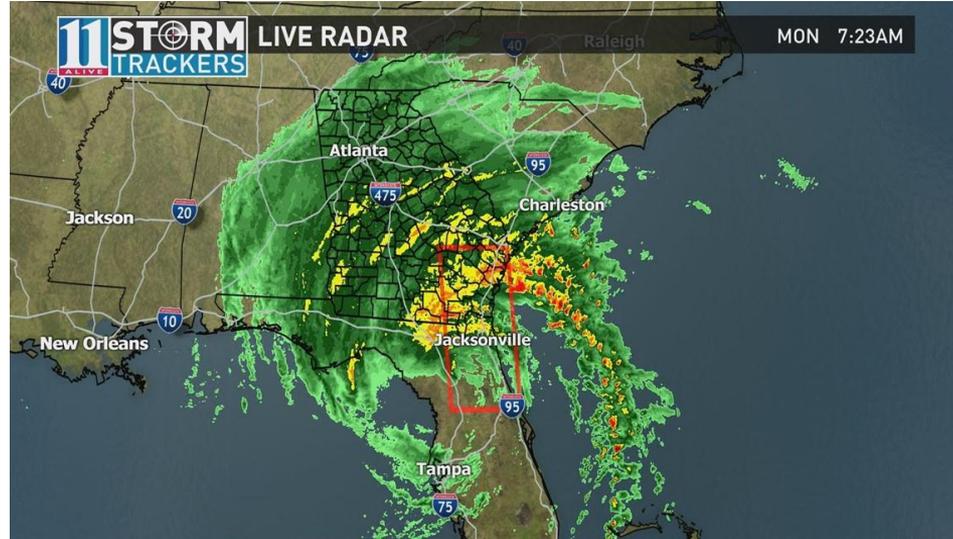
Wind from Weather Underground

- September 10-11, 2017
- Category 3 hurricane as it came up the western coast of Florida and downgraded to a tropical storm as it continued its path northwest through Georgia.
- Wind gusts of 60 mph were recorded ENE at the Brunswick Airport
- Mandatory evacuations were issued for coastal Georgia
- Inspection of the living shoreline after the storm verified that the project remained **intact and stable** and served to protect the adjacent upland

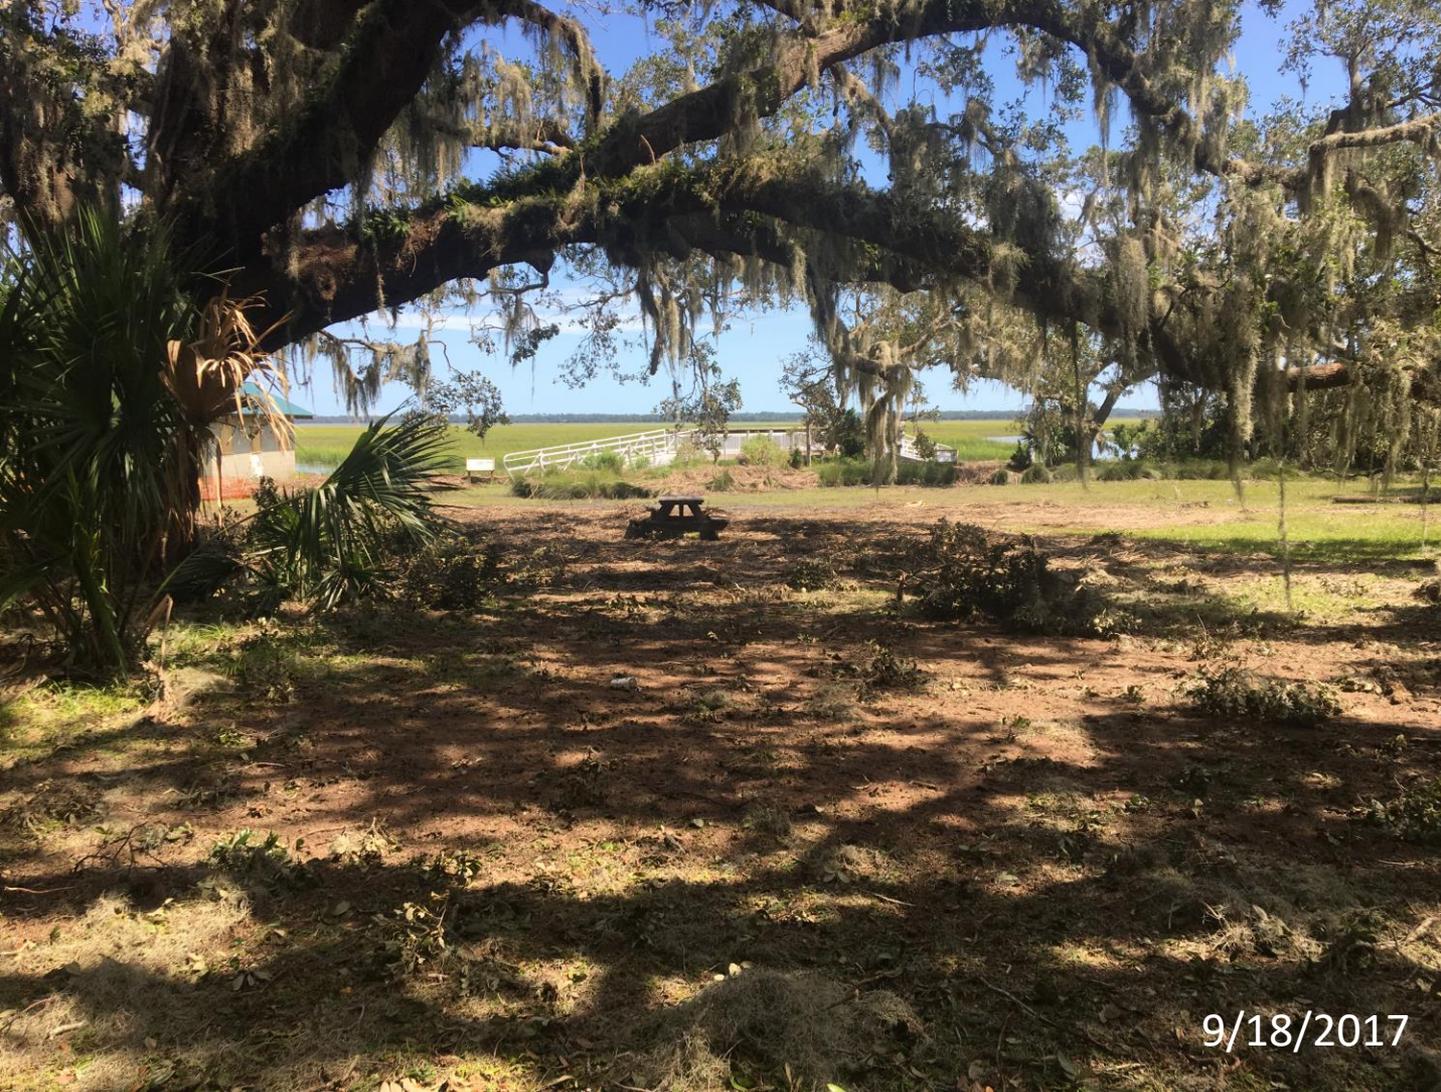
9/18/2017

Storm surge was roughly 157 feet from mean high tide line along the demonstration living shoreline. As the tide receded, it left behind wrack and debris along the upland and the creekbank.

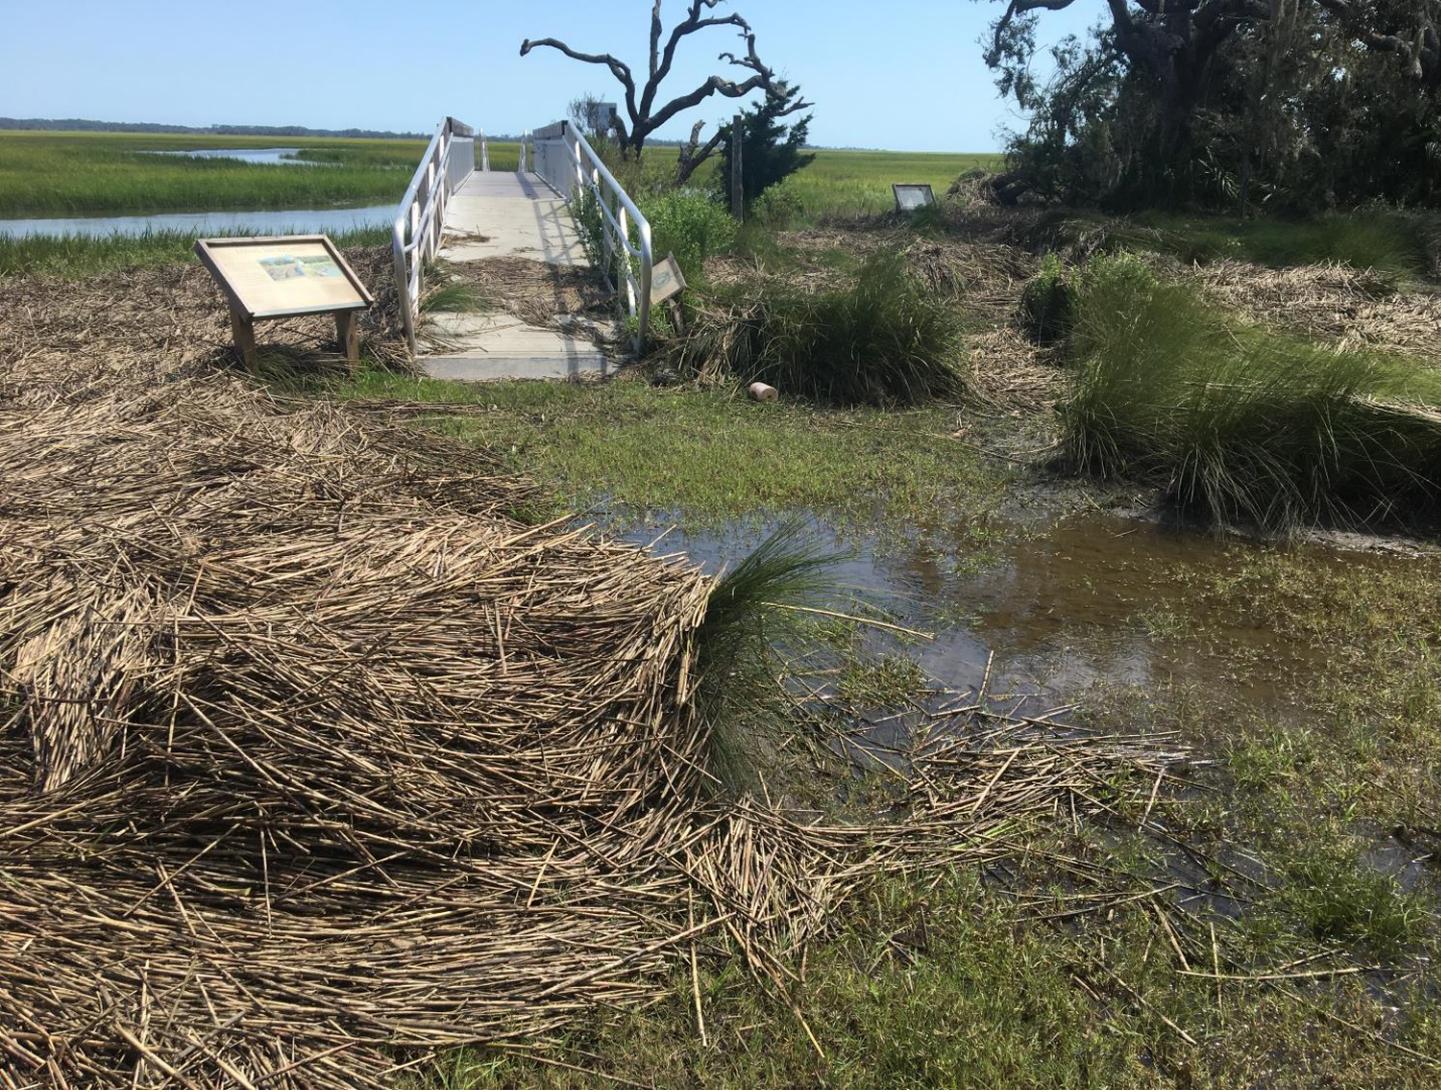
Per the project design and the natural connectivity between the upland and creek, the living shoreline allowed for storm surge to over-wash the upland and leave the creekbank intact as the surge withdrew.

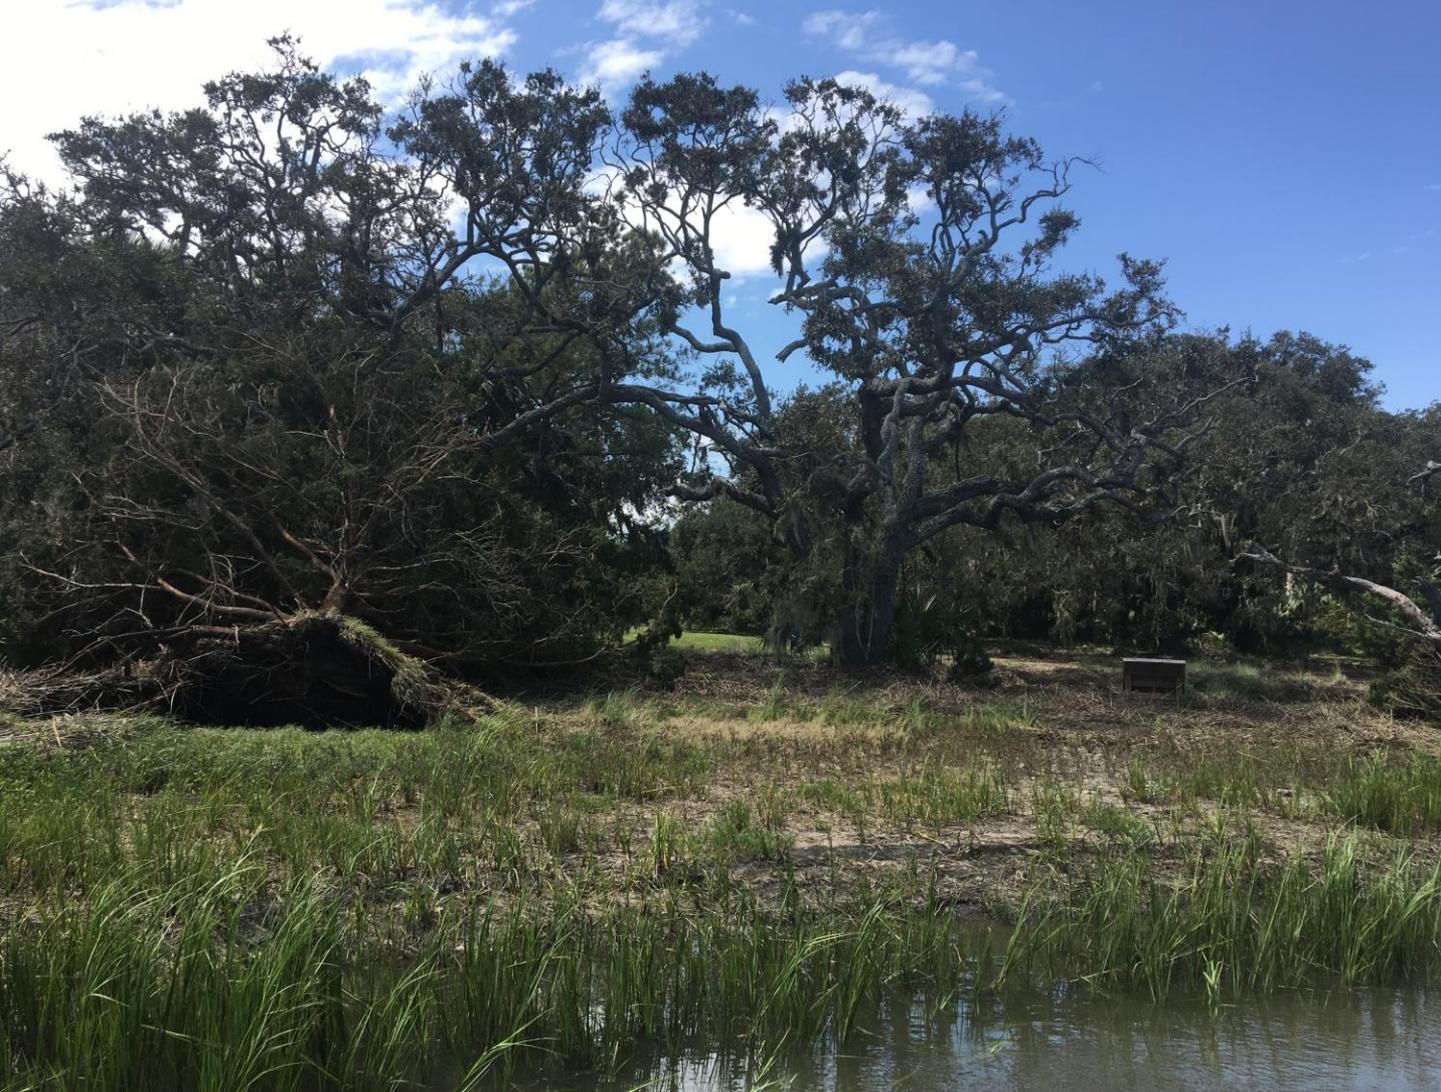
A single southern red cedar tree along the upland component of the project was lost during the storm. This is believed to be due to wind gusts and has not affected the stability of the project.

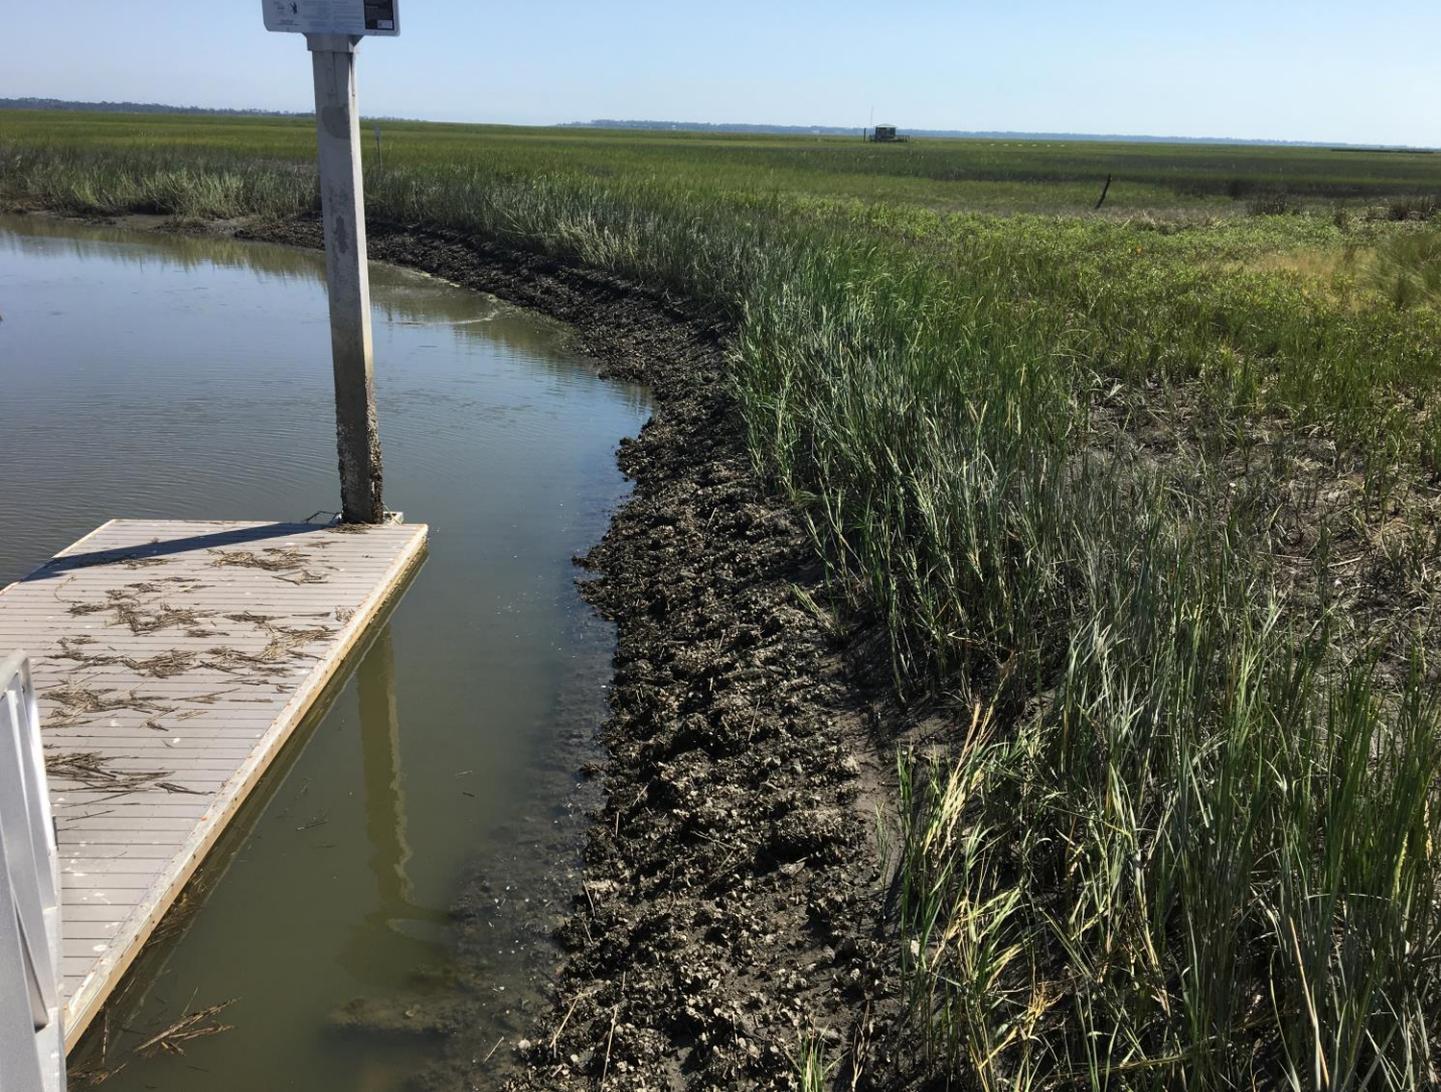
Looking east along Lawrence Creek, notice the living shoreline where the oyster reef and upland **remained stable** throughout storm.

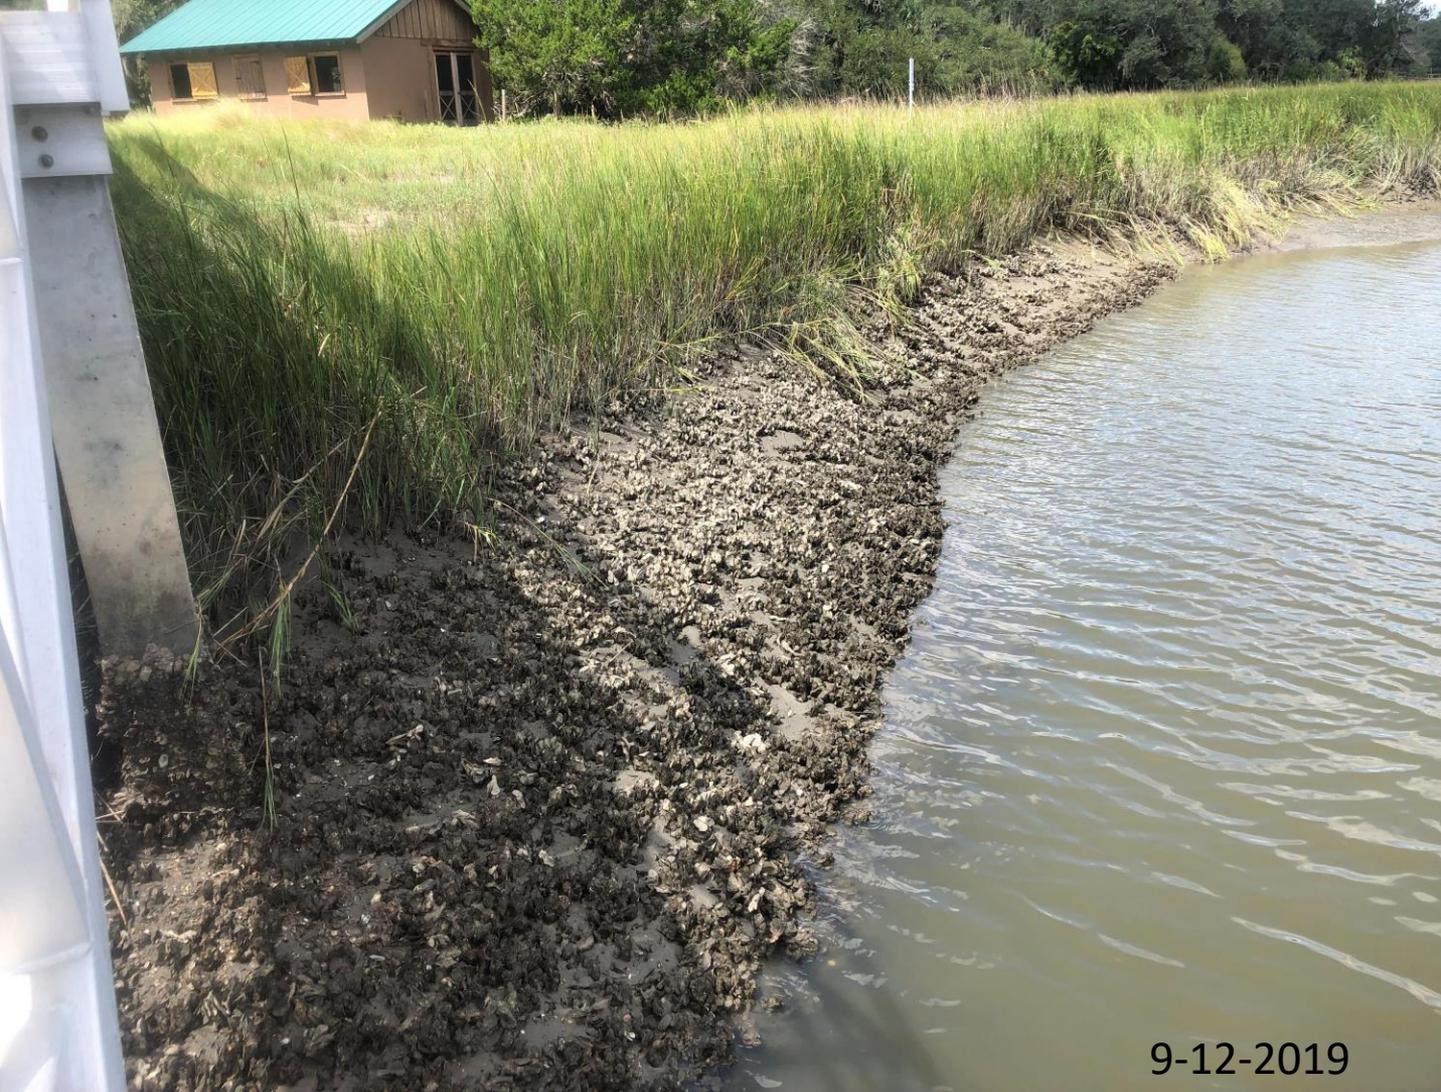
9-12-2019

No significant wrack debris was left behind by the storm and the project remains intact. The living shoreline project at Cannon's Point Preserve has remained stable through:
