Living Shoreline at Cannon's Point Preserve

Cannon's Point Preserve Living Shoreline

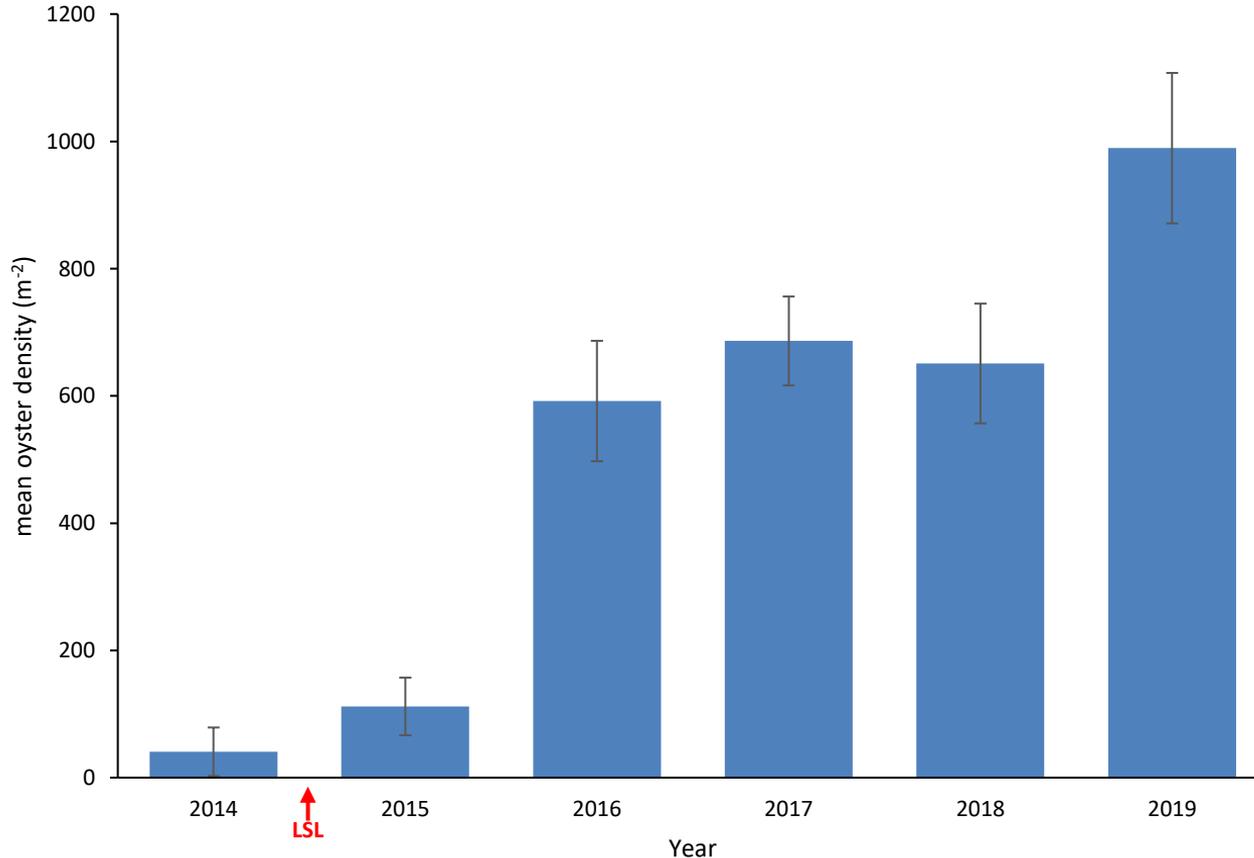
Mean Oyster Density

Figure 1. Mean (\pm SE) density of oysters (*Crassostrea virginica*) before and after the 2015 construction of a living shoreline (LSL) on Lawrence Creek, Cannon's Point Preserve, St. Simons Island. Live oysters measuring at least 10 mm in height were sampled in 0.25-m² quadrats along 8 transects in the lower intertidal zone at the end of each growing season.

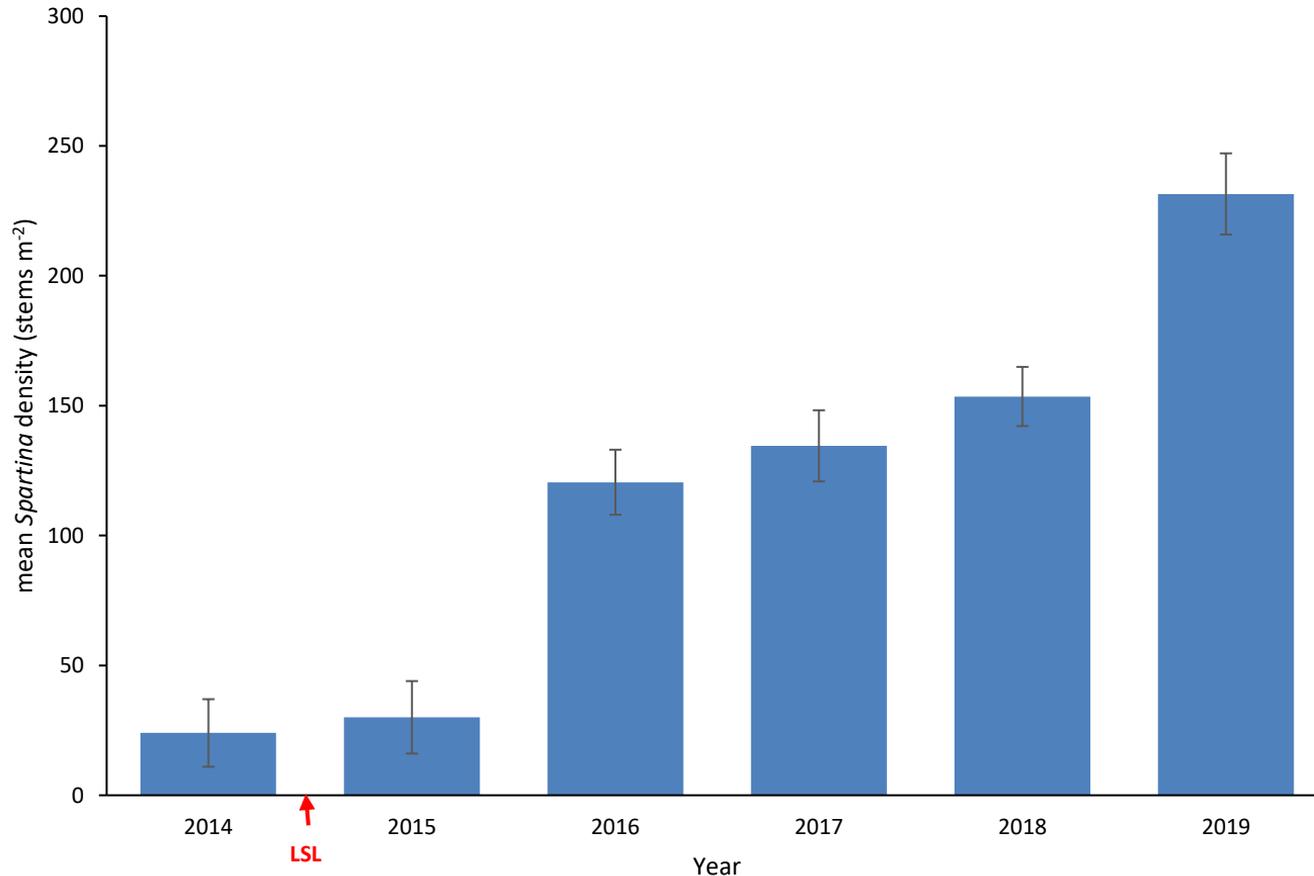
Mean Spartina Density

Figure 2. Mean (\pm SE) density of smooth cordgrass (*Spartina alterniflora*) before and after the 2015 construction of a living shoreline (LSL) on Lawrence Creek, Cannon's Point Preserve, St. Simons Island. Plants were sampled in 0.25-m² quadrats along 8 transects in the upper intertidal zone at the end of each growing season.
